NATIONAL BUREAU OF STANDARDS REPORT

2585

June 19, 1953

REPORT OF
INSPECTION OF PLASTER WORK AT
ALASKA NATIVE SERVICE HOSPITAL
AND TESTS FOR QUALITY AND
CHARACTERISTICS OF PLASTER MATERIALS

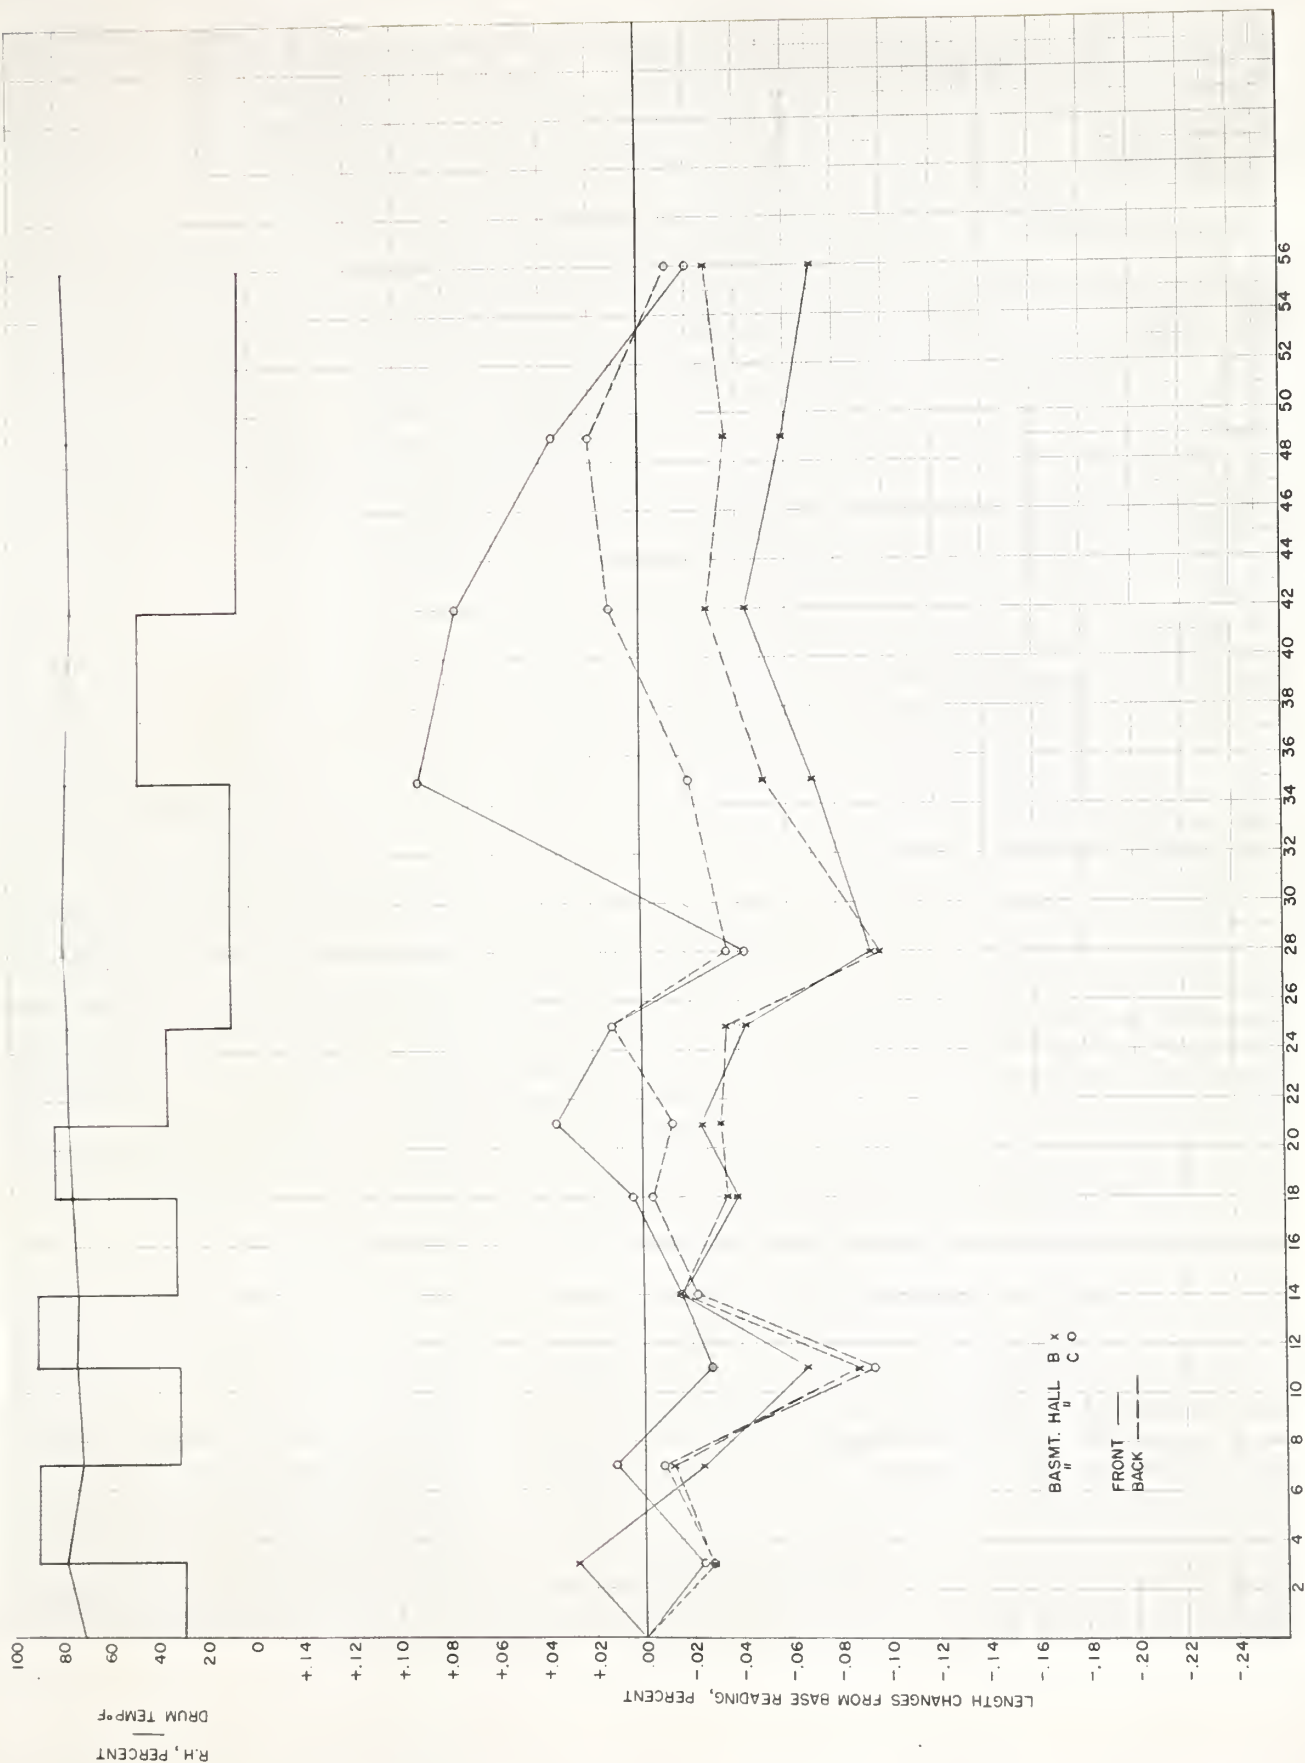
The changes of length of the specimens in terms of percentage of the 10-inch gage length are shown in figures 1 and 2. These are typical of the behavior of the twenty-two specimens subjected to the tests. In some instances there appeared to be evidence that the expansion of the plaster caused flexing of the lath, thus producing marked or anomalous differences in the lengthening or shortening of the gage length of the specimens during the period in which it was subjected to a constant humidity. Some of these anomalies have been attributed to cracking of the base-coat plaster or both the base-coat plaster and the white-coat finish, thus allowing the metal lath, already strained by the shrinking plaster, to regain its length to the extent that the strain from shrinkage of the plaster had been relieved.

Figure 1. Changes in length of specimens of lath and plaster from basement corridor in percentage of a 10-in. gage length when subjected to changes in humidity.

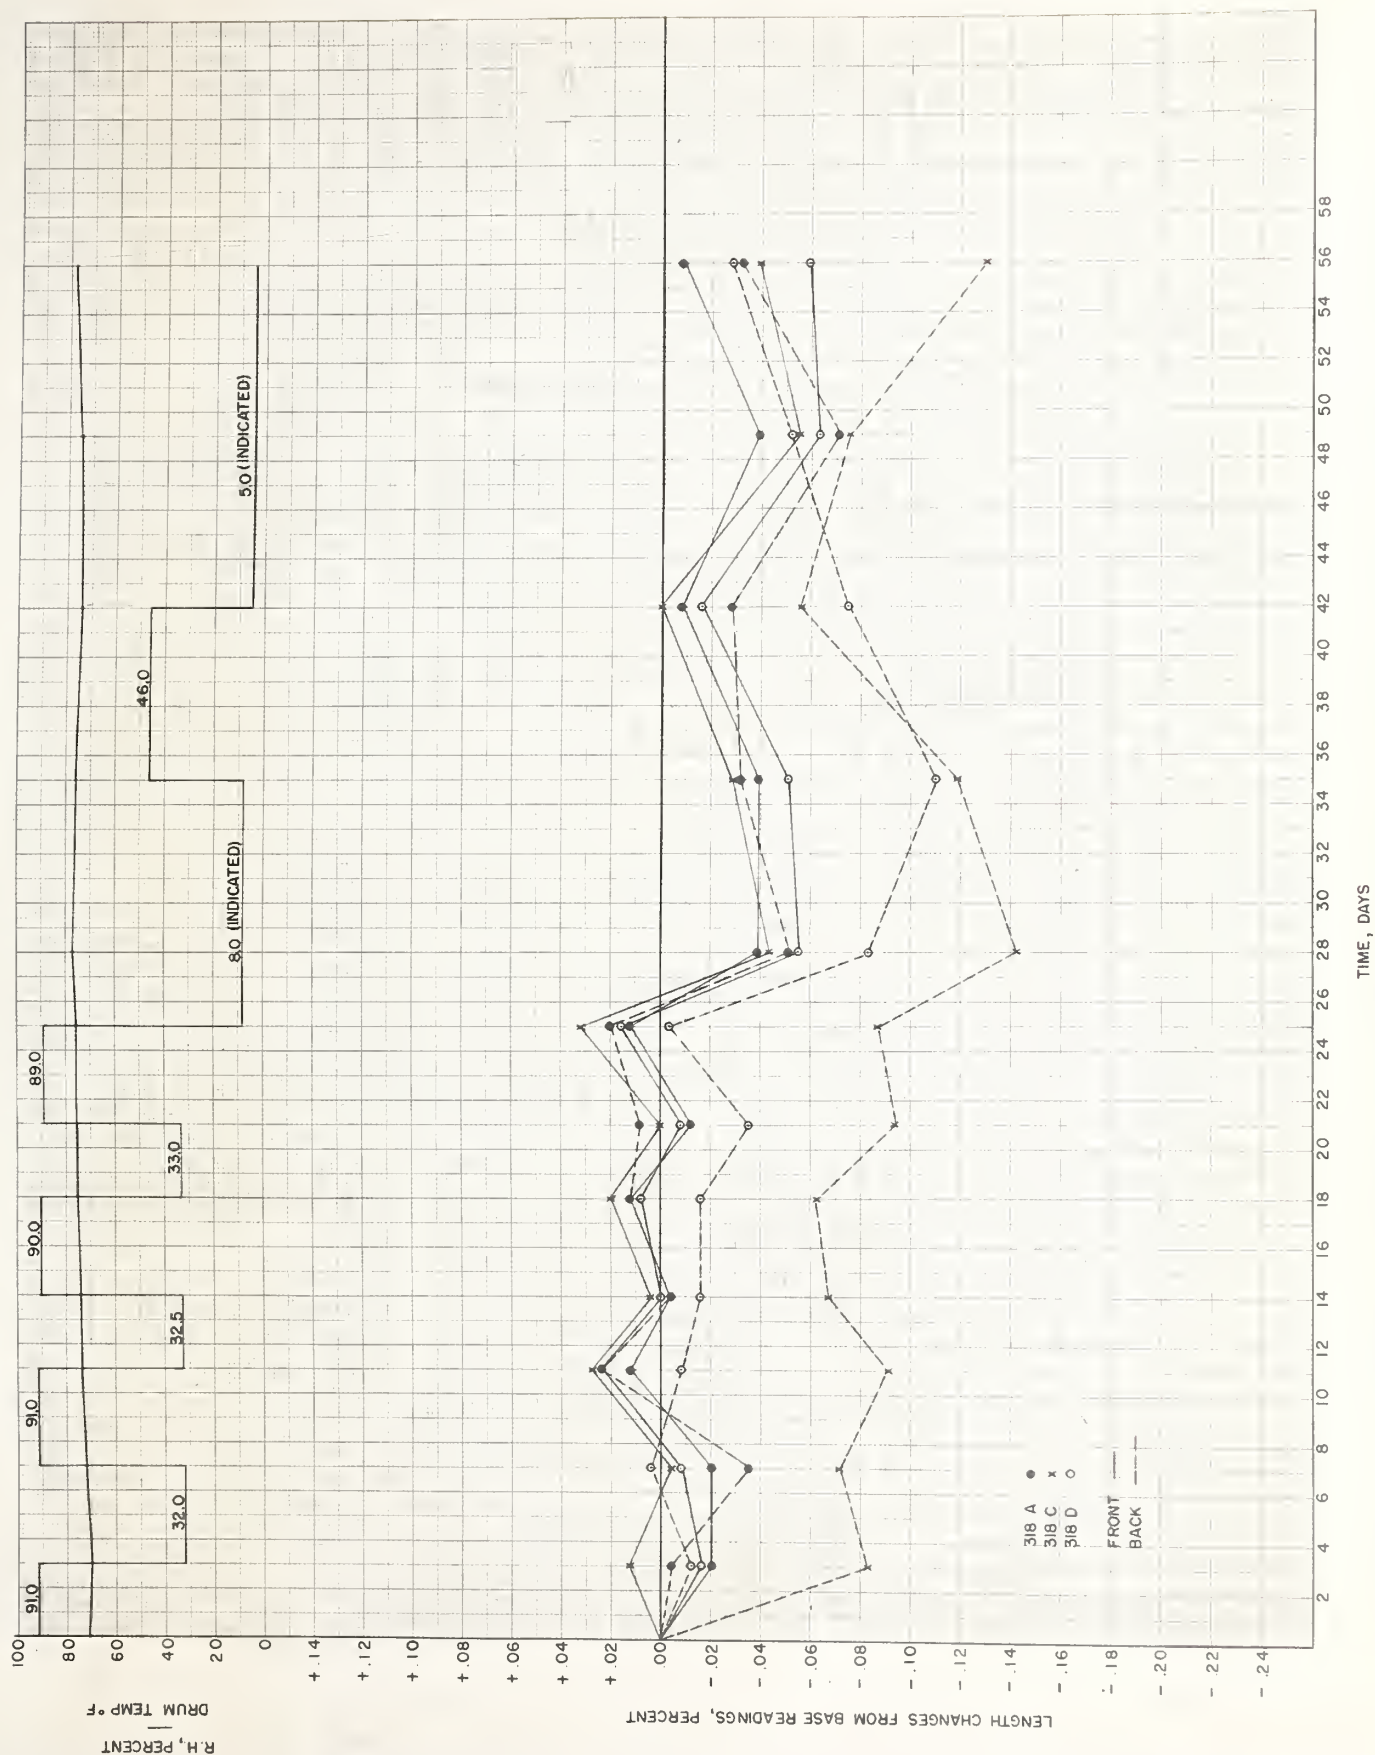
Figure 2. Changes in length of specimens of lath and plaster from room 318 in percentage of a 10-in. gage length when subjected to changes in humidity.

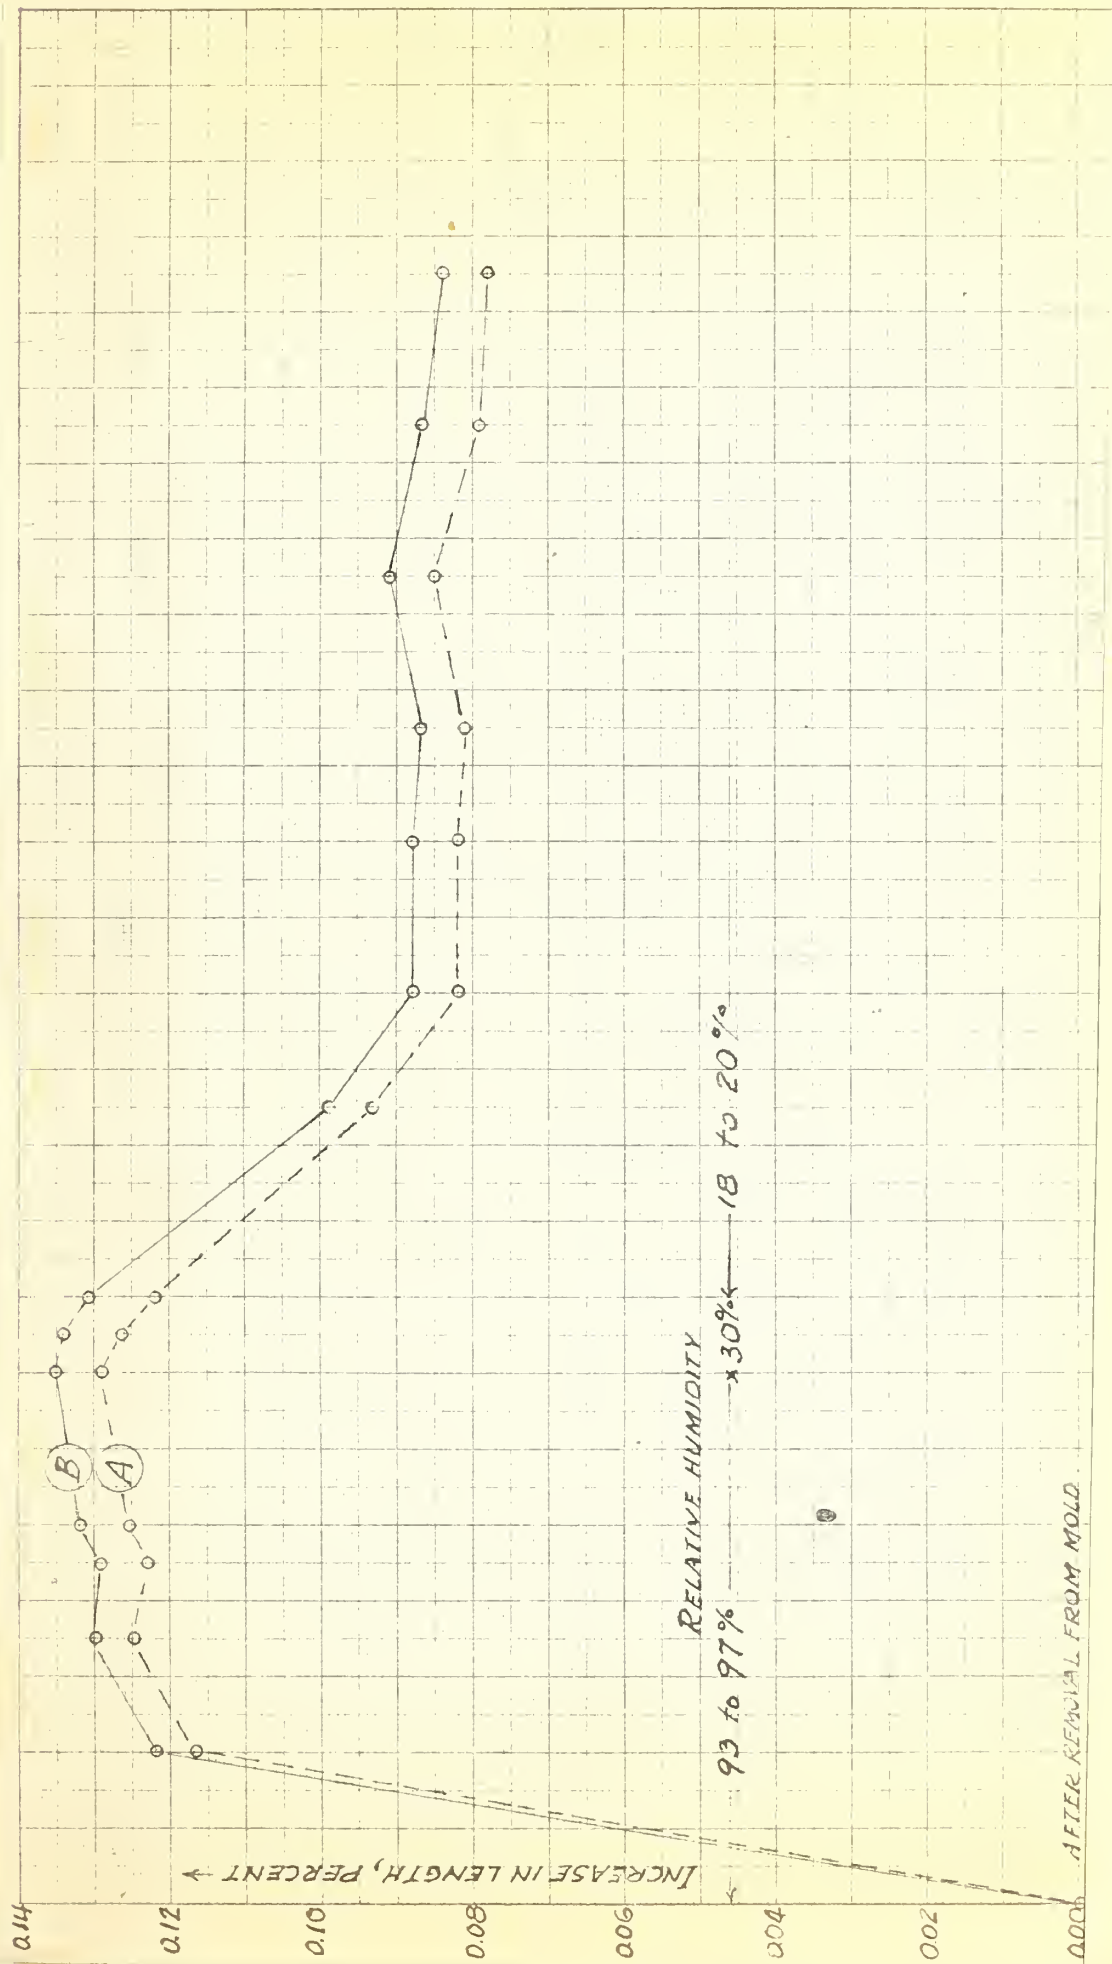
Two test bars of plaster designated A and B were cast in steel molds in order to study the behavior of the typical plaster mix when subjected to changing conditions of humidity. The bars were cast in molds to give an effective length of 10 inches between steel plugs cast into the ends of the bars. The bars were made from plaster having the composition: 20 parts fibered-gypsum cement, 8 parts vermiculite, and 5 parts Alaska sand by weight. Bar B had 10 percent more water in the mix than did bar A. The 1- by 7/8-inch bars had a 1/16 inch thick white finish applied to one face after they had been removed from the molds and measured for expansion. The changes in length of the two bars are shown in figure 3. On release from the constraint of the molds, the bars expanded 0.02 and 0.03 percent of their length at once, and after having lain horizontally without other restraint than their own weight for 4 days in a chamber at 70° F and at 93 to 97 percent relative humidity, the bars were found to have increased in length by 0.117 and 0.122 percent. During the next 10 days, at the same humidities, increases of 0.012 and 0.013 percent in length were observed, making the total expansion from the beginning of storage at high humidity 0.129 and 0.135 percent, respectively. The bars were then placed in a chamber held at 70° F and at 30 to 40 percent relative humidity for 2 days. The shrinkage during these 2 days amounted to not more than 0.007 percent. During the next 8 days, however, after storage in the chamber held at 18 to 20 percent relative humidity, the shrinkage amounted to 0.040 and 0.043 percent for specimens A and B, respectively. The shrinkage during the next 19 days, under the same humidity conditions, amounted to 0.004 percent. From the point of maximum expansion the shrinkage at the end of 29 days' storage in chambers in which the relative humidity was lowered by stages to 18 percent had reached 0.052 percent and appeared to be continuing.
